Paired MVER and RH Measurements

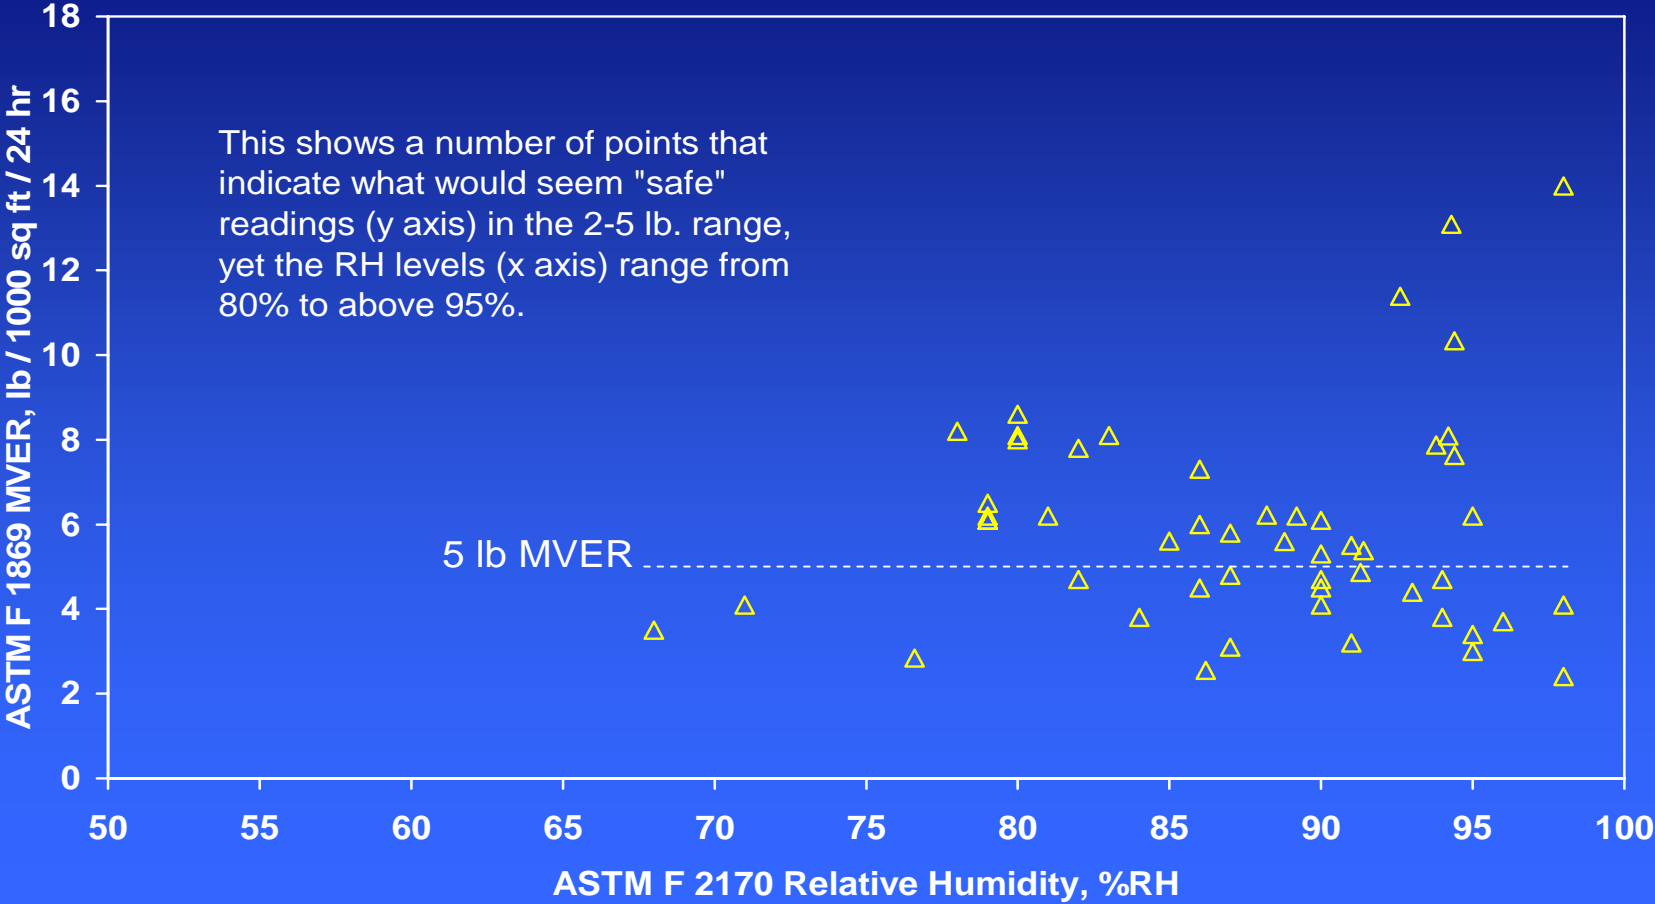
This graph clearly shows that even though a floor tests below 5lbs. the interior of the slab can have excess moisture leading to potential flooring failure.
